## Test report # PF21003

**Client: New Zealand Structural Insulated  
Panels (NZSIP) Limited**

**Fire resistance tests for loadbearing vertical  
separating element - wall**

**Test method: AS 1530.4:2014**

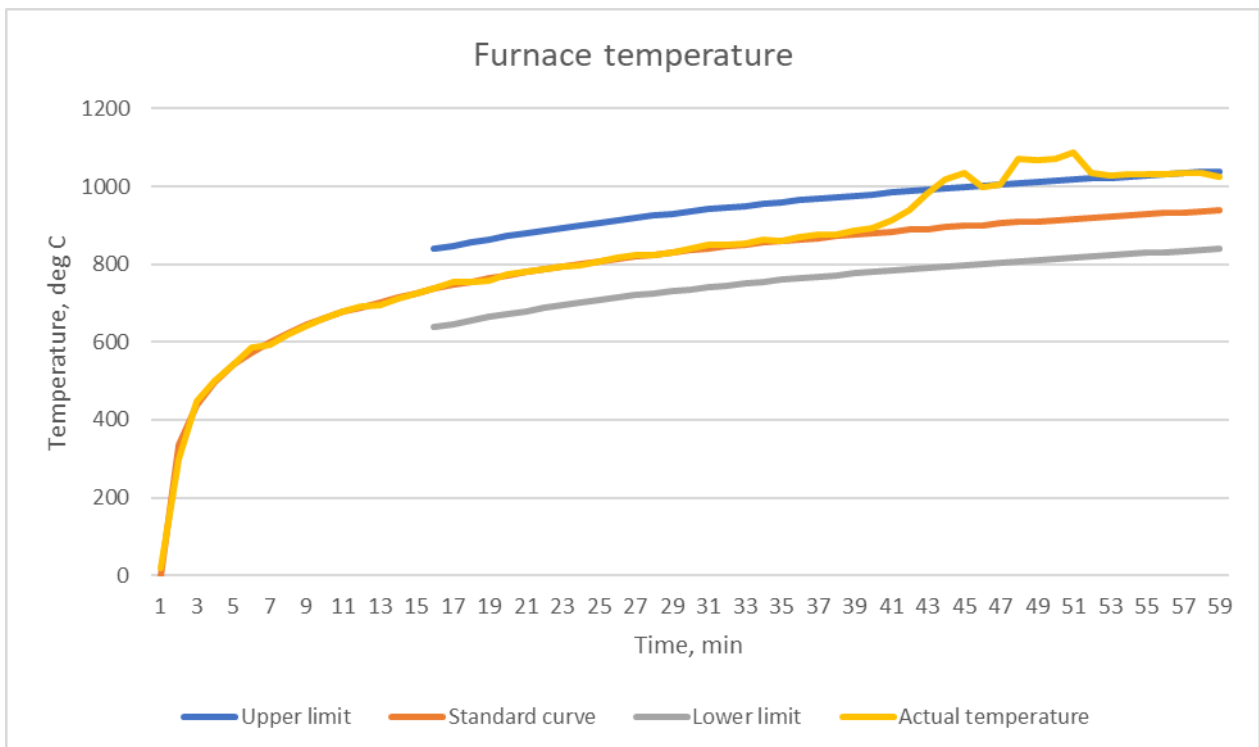
At 38 minutes sudden combustion of the polyurethane foam occurred. Due to the nature of the polyurethane foam burning—self-sustaining burning of the foam continued throughout the test till 58 minutes, when most of the foam burned out, the rest was extinguished with water.

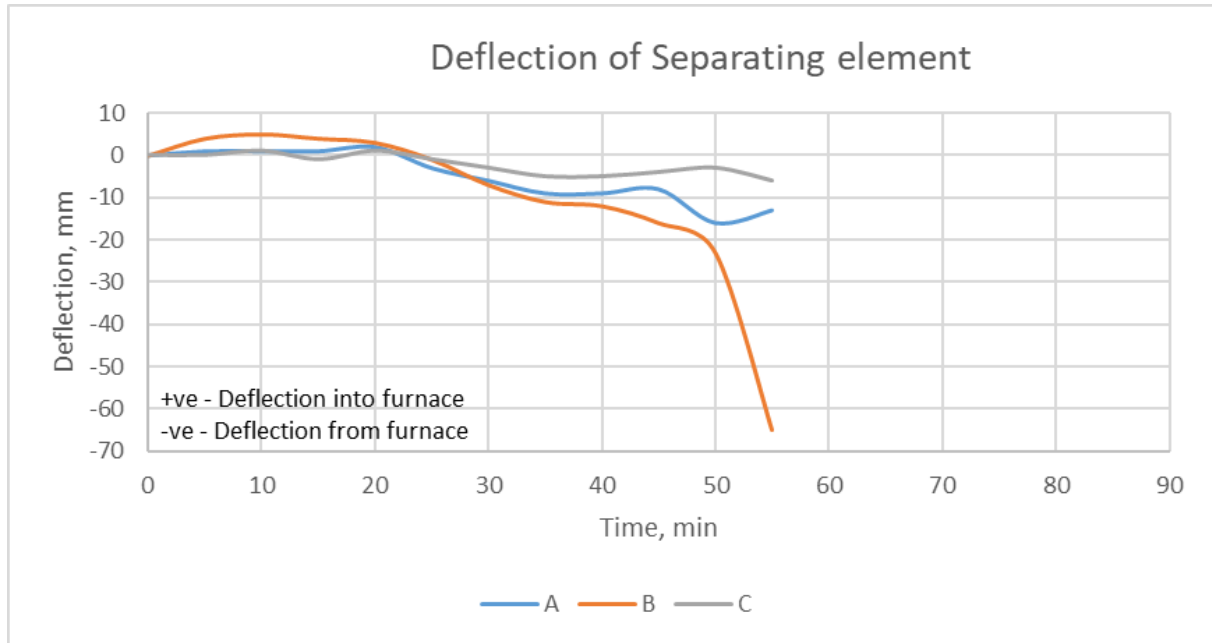
## 10.2 Deflection measurements

Time, min	A, mm	B, mm	C, mm
0	0	0	0
5	1	4	0
10	1	5	1
15	1	4	-1
20	2	3	1
25	-3	-1	-1
30	-6	-7	-3
35	-9	-11	-5
40	-9	-12	-5
45	-8	-16	-4
50	-16	-23	-3
55	-13	-65	-6

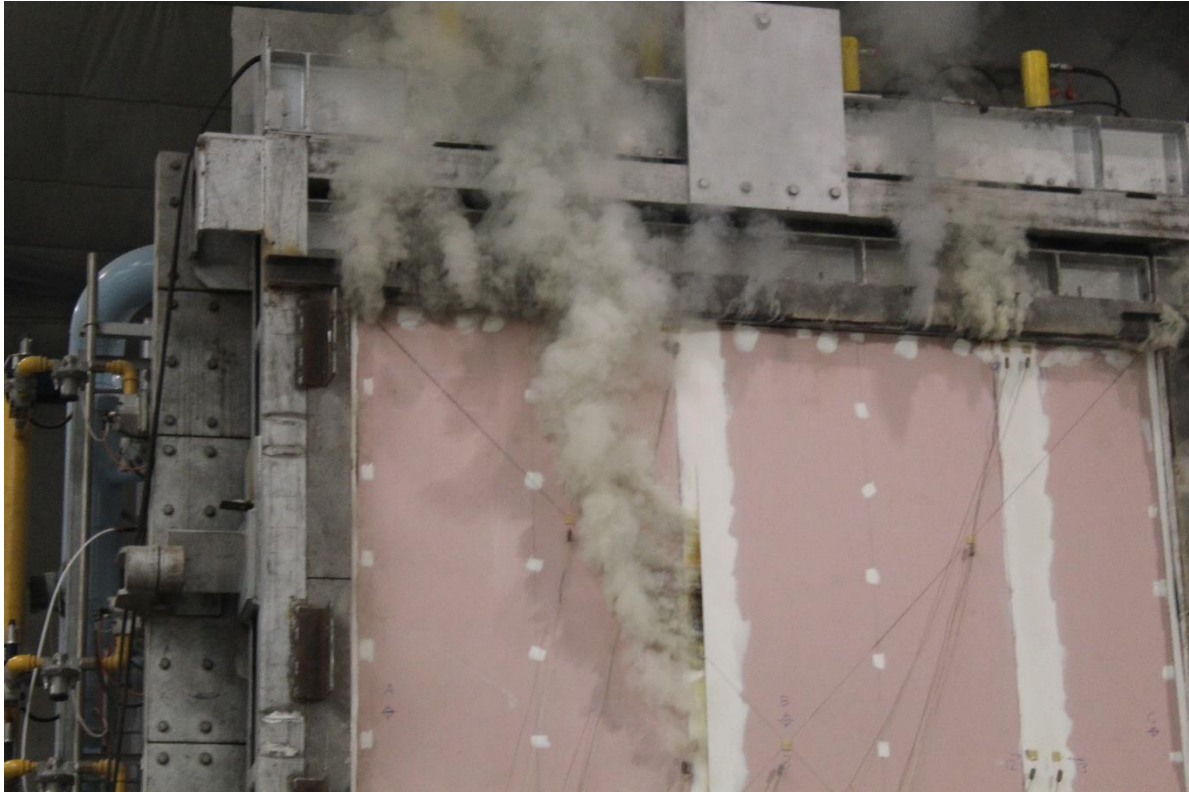
53 minutes:

Time Minutes	Test Face	Observations
10	E/U	No notable changes
12	E	Sealing tape used for junctions have combusted
20	E	Dark discolouring within screw locations
26	U	Minor visible smoke from frame and specimen junctions above TC10
32	E	Junctions between specimen have further discoloured, near the left side of each junction (exposed view)
40	E	Unable to see inside furnace due to exponential increase of flames
45	U	Dark Yellowish smoke from top junction near the centre
50	U	Very dark yellow smoke from above TC10
53	U	Large gap in plasterboard junction, heavy smoke
53	U	Cotton pad test for 30 seconds near gap - Pass
57	U	<b>Large flames coming from gap in plasterboard junction – Flaming to the unexposed face for 10 seconds or longer shall be deemed Integrity failure.</b>
58		<b>Test discontinued due to specimen collapse</b>

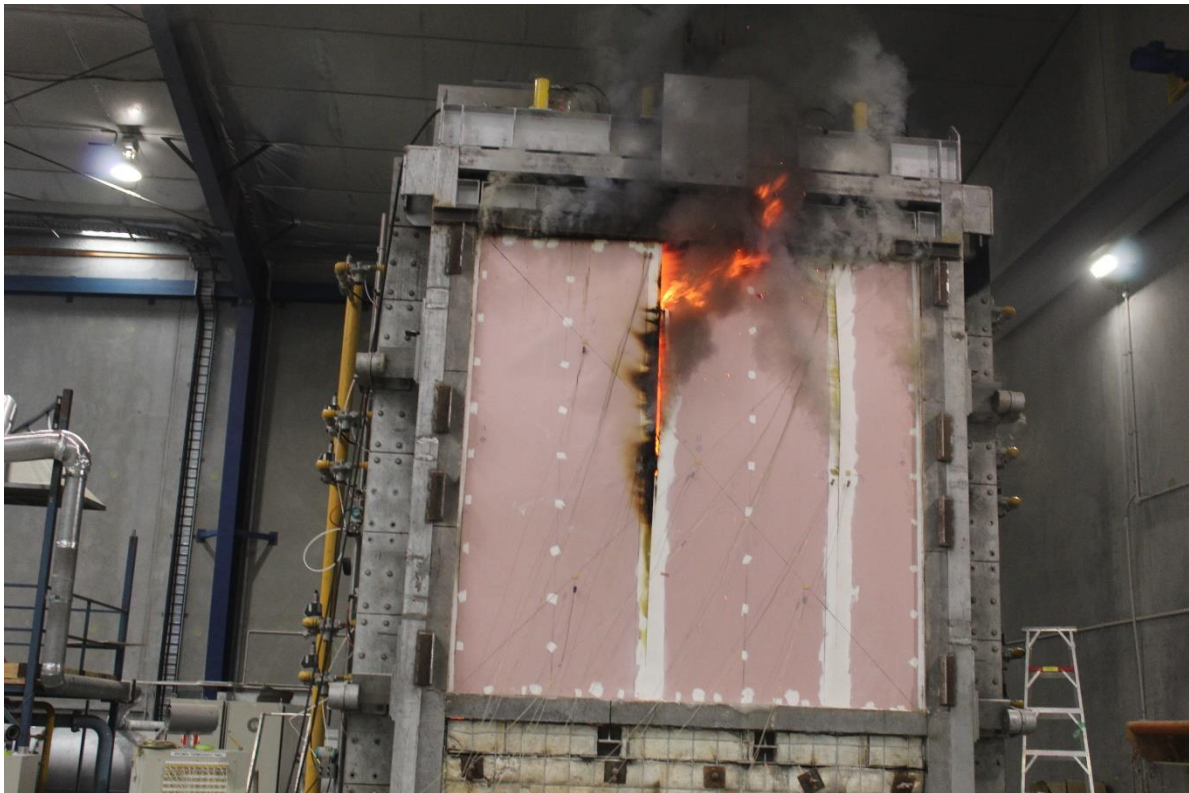
57 minutes:

<b>Test results – 115mm NZSIP Panel with lining both sides</b>	
<b>Structural adequacy</b>	<b>58 minutes</b>
<b>Integrity</b>	<b>57 minutes</b>
<b>Insulation</b>	<b>57 minutes</b>
<b>Fire resistance level (FRL)</b>	<b>30/30/30</b>

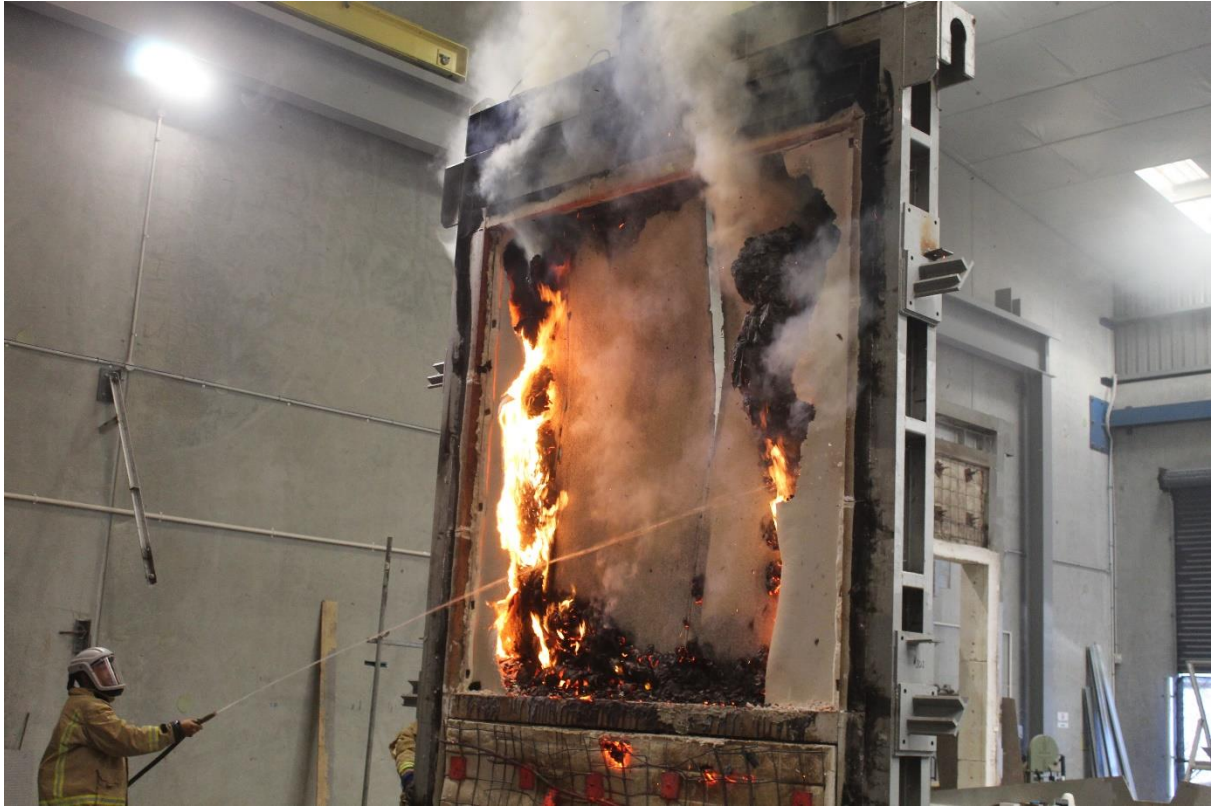
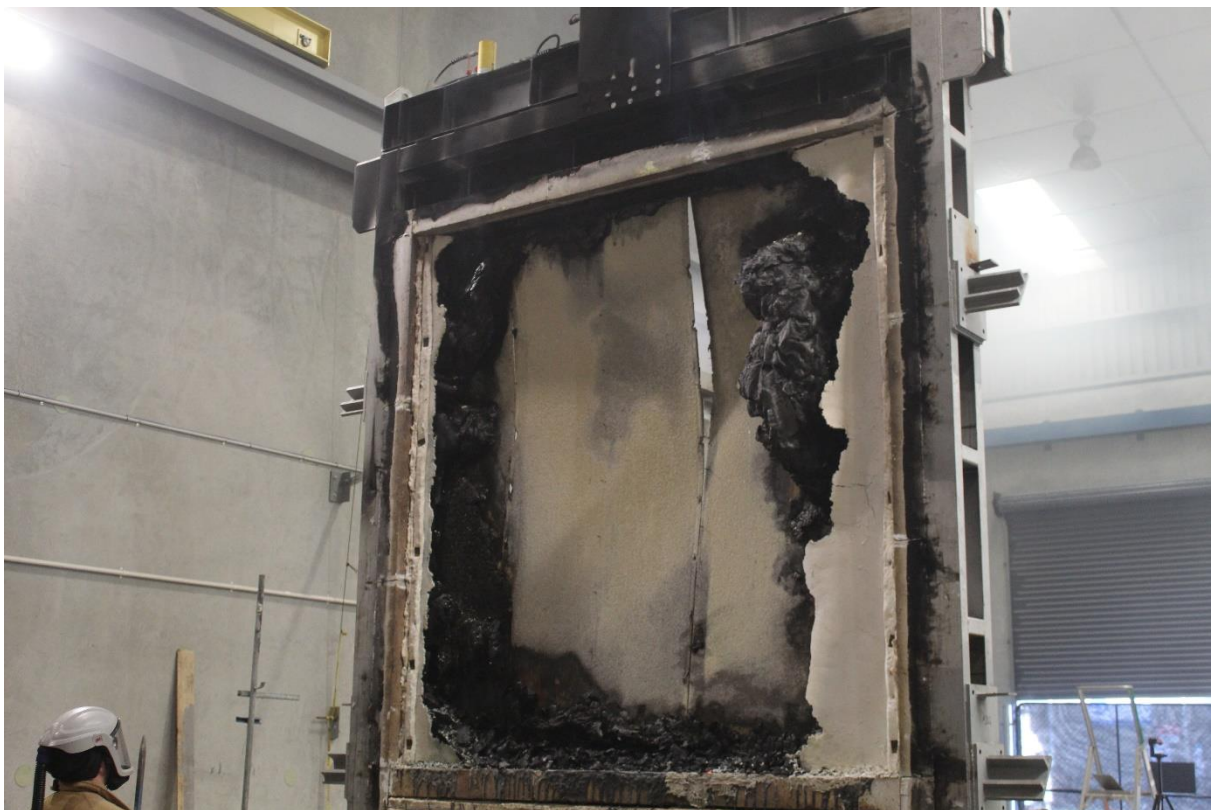
After the test:

The test was discontinued at 58 minutes. The test was discontinued due to specimen collapse.
