## Test report # PF21003

**Client: New Zealand Structural Insulated  
Panels (NZSIP) Limited**

**Fire resistance tests for loadbearing vertical  
separating element - wall**

**Test method: AS 1530.4:2014**

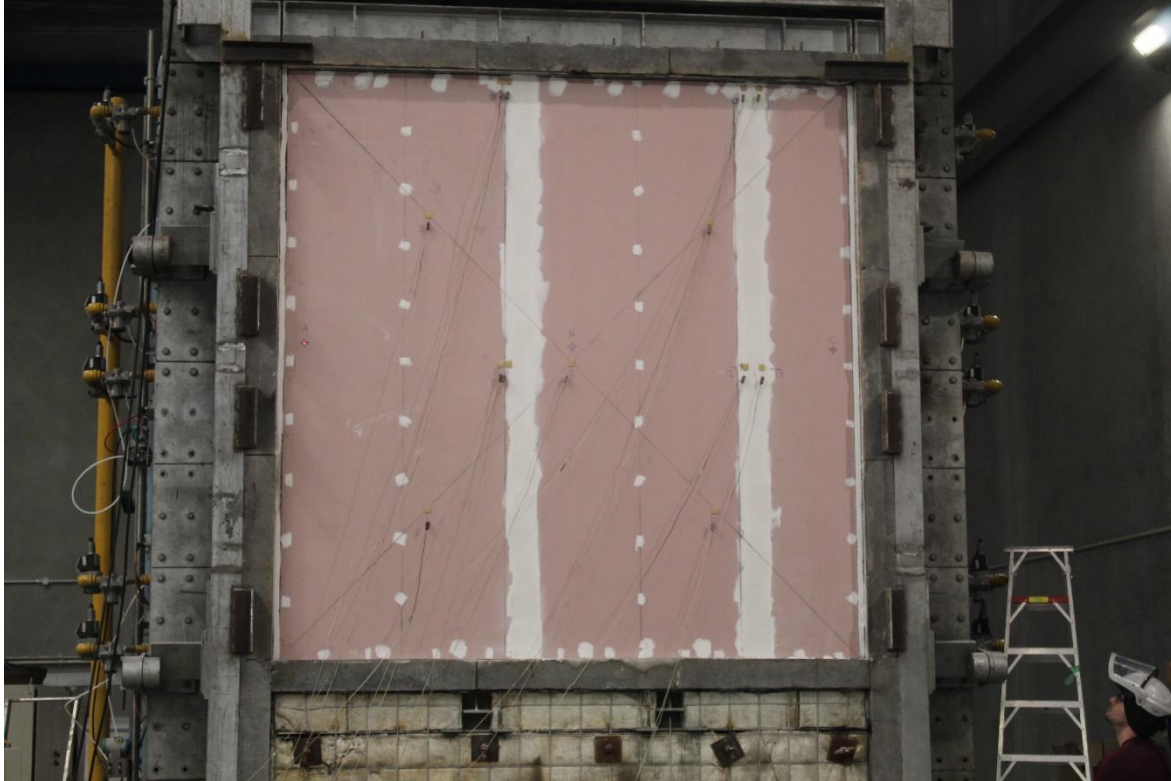
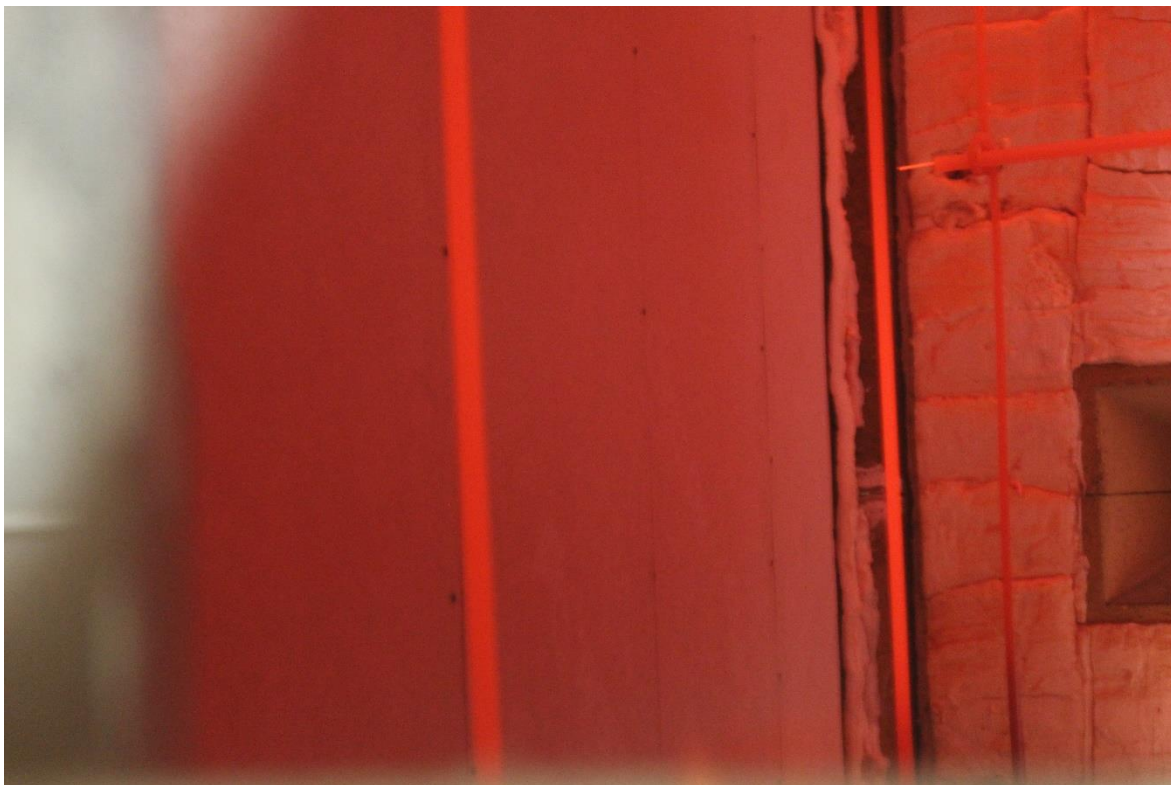
10 minutes:

Time Minutes	Test Face	Observations
10	E/U	No notable changes
12	E	Sealing tape used for junctions have combusted
20	E	Dark discolouring within screw locations
26	U	Minor visible smoke from frame and specimen junctions above TC10
32	E	Junctions between specimen have further discoloured, near the left side of each junction (exposed view)
40	E	Unable to see inside furnace due to exponential increase of flames
45	U	Dark Yellowish smoke from top junction near the centre
50	U	Very dark yellow smoke from above TC10
53	U	Large gap in plasterboard junction, heavy smoke
53	U	Cotton pad test for 30 seconds near gap - Pass
57	U	<b>Large flames coming from gap in plasterboard junction – Flaming to the unexposed face for 10 seconds or longer shall be deemed Integrity failure.</b>
58		<b>Test discontinued due to specimen collapse</b>
